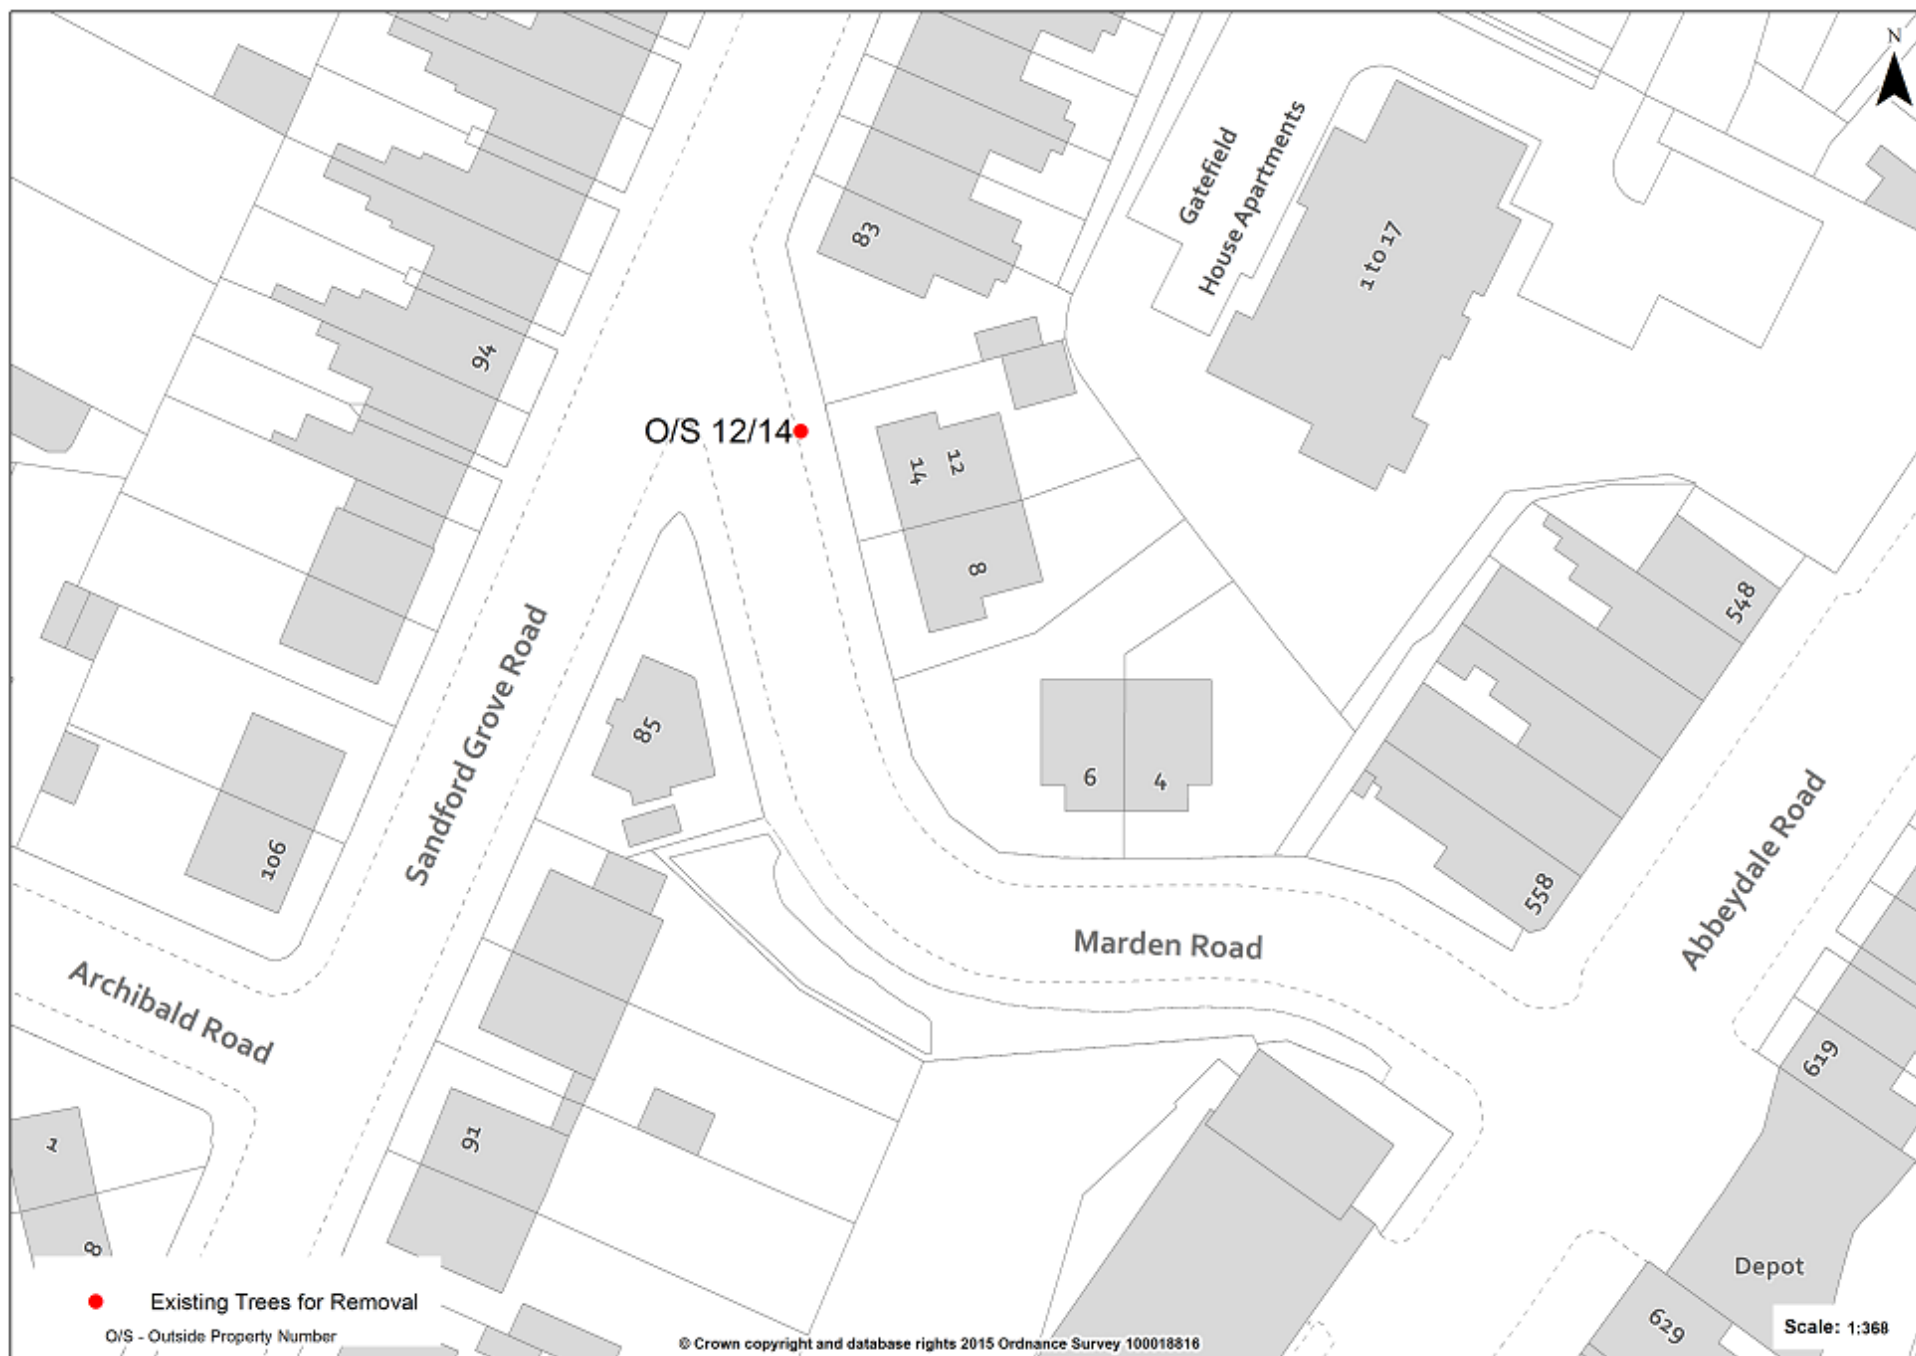
Site Name	Feature Location	6 D's	Reasons	Existing species	Planting notes	Replant species
MARDEN ROAD	o/s 12/14	Damaging	Rooting in f/w tarmac into cross-over, rooting in c/w, kerbs displaced, cannot remedy without root damage	Platanus x hispanica	Plant in new 800mm pit between 14 and adjoining property (moved downhill 10m to clear driveway)	Corylus colurna
